# 2022 St. Louis River Area of Concern Celebration of Progress

**November 10, 2022**

SLRAOC Coordinators: Rick Gitar (FdL), Barb Huberty (MPCA),  
Melissa Sjolund (MNDNR) and Matt Steiger (WDNR)

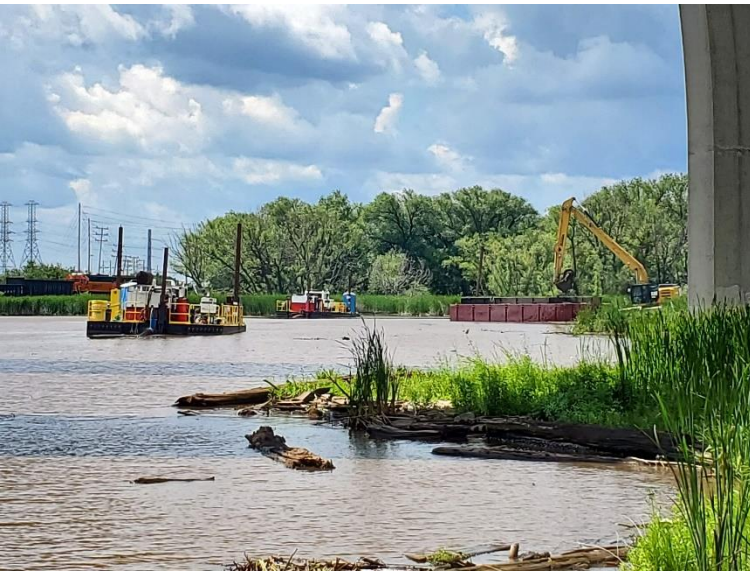
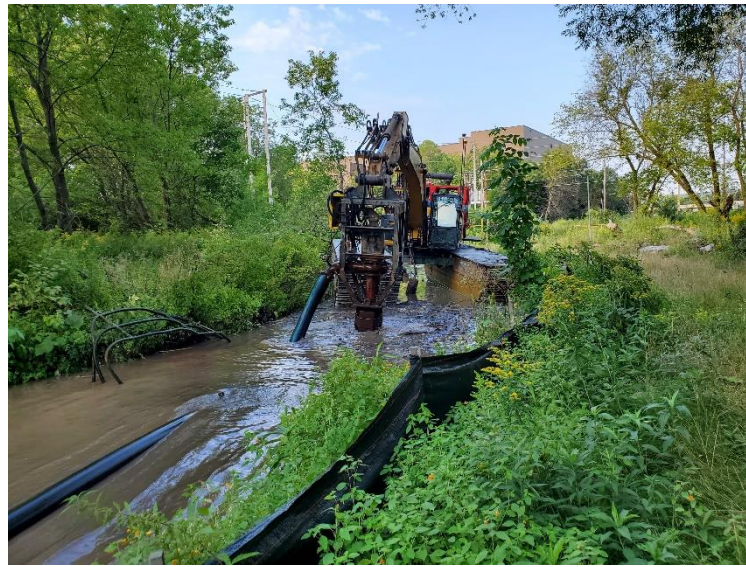
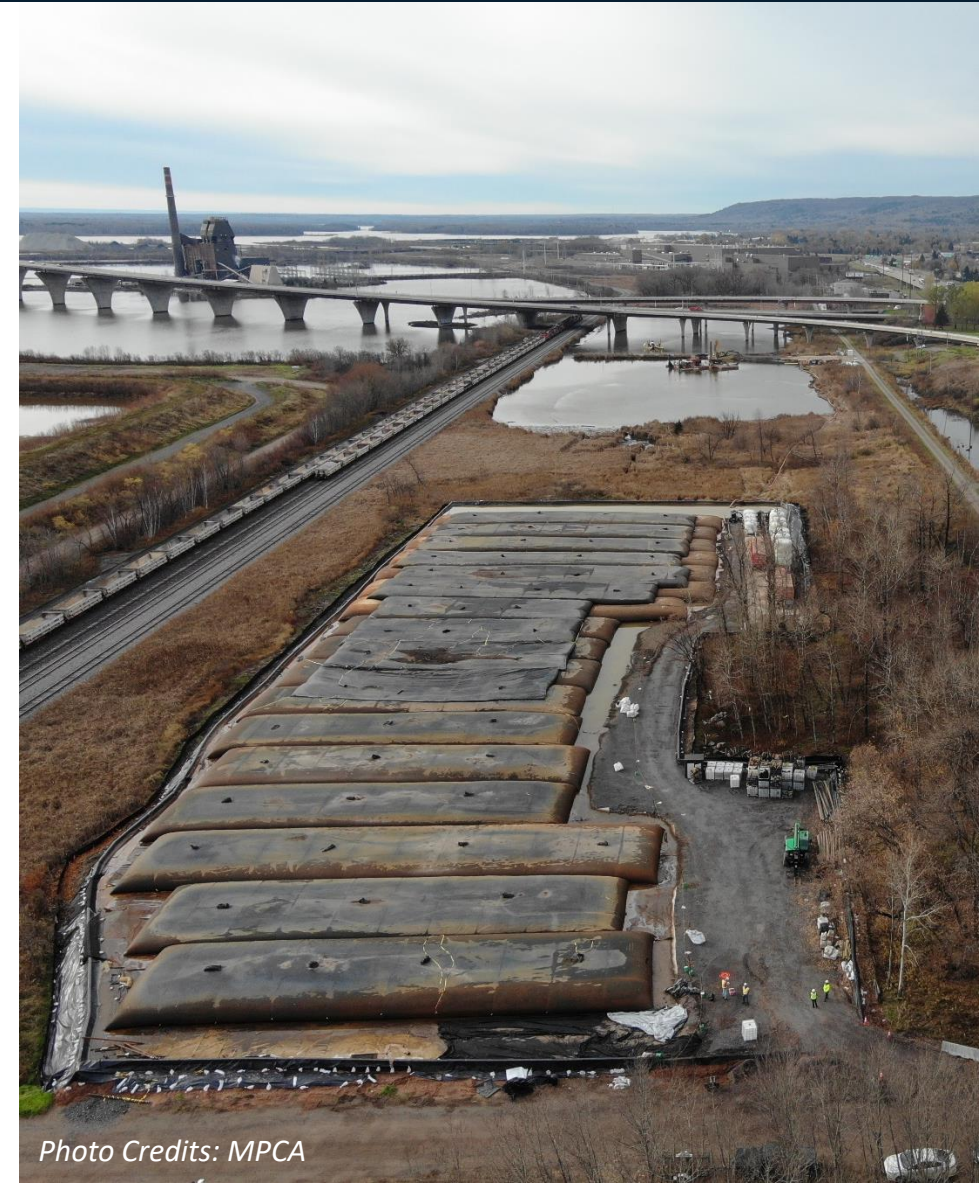
- Placed 238 tons of pelletized activated carbon
- Placed 5,403 tons of sand in higher flow areas
- Remediated ~55,000 cy contaminated sediment
- Installing new access road, boat launch, & ADA-compliant access for fishing pier & paddle sport launch

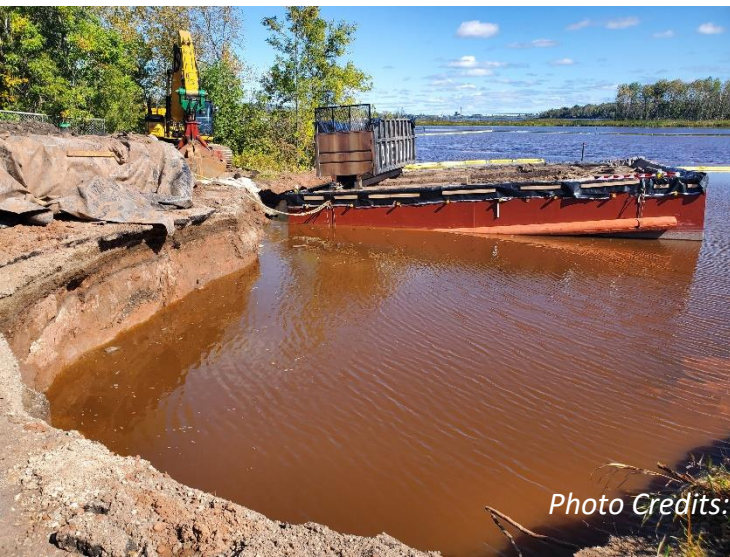
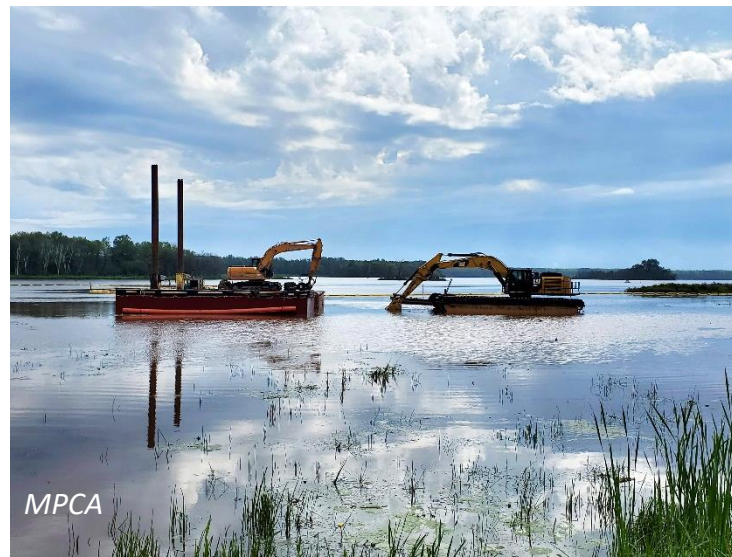
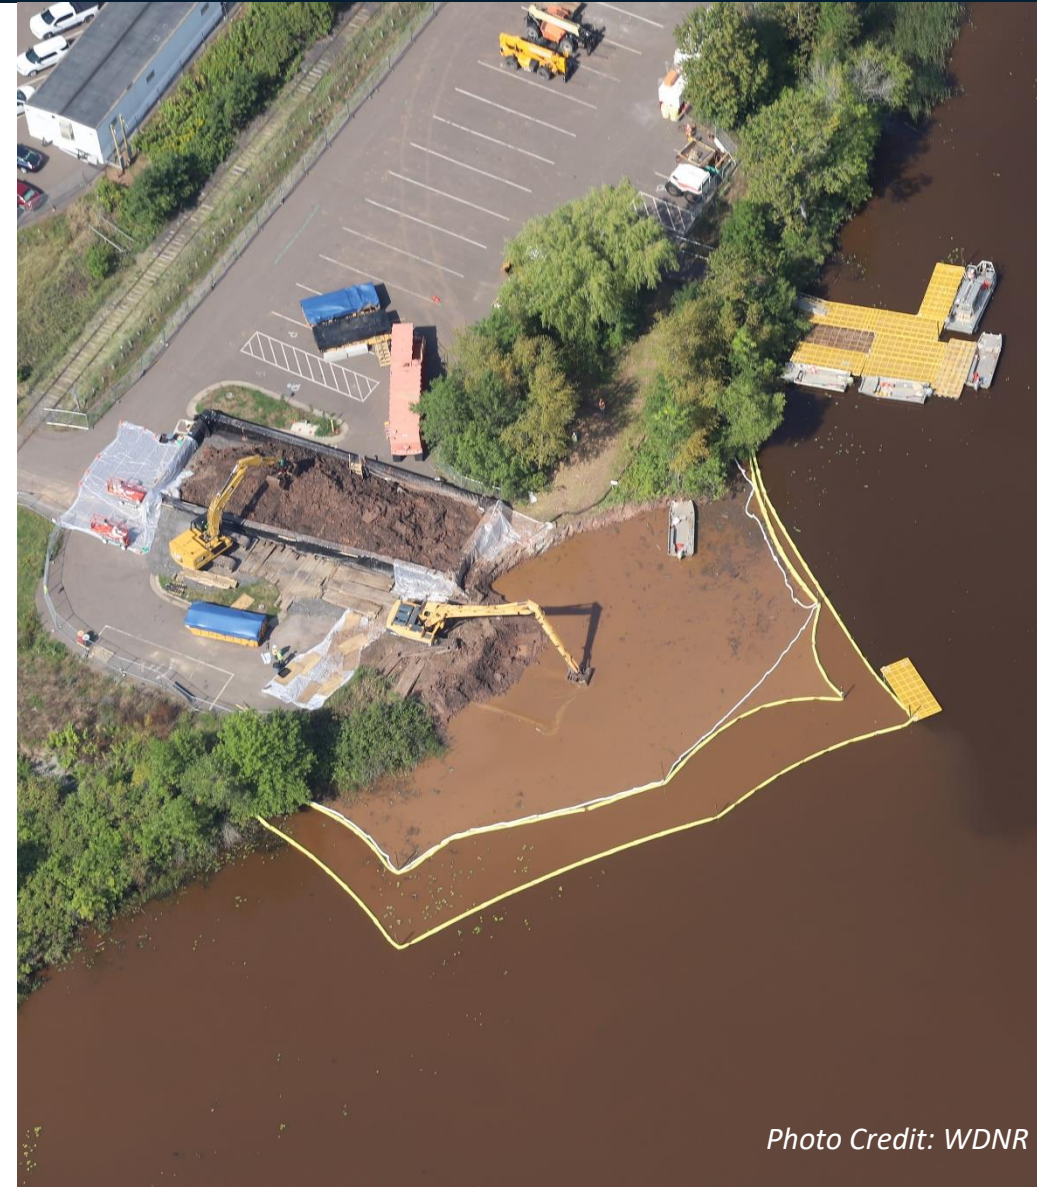
- Debris removed & disposed at landfill
- Dewatering/water treatment system at Hallett Dock 7
- 487 cy TSCA soil & 282 cy TSCA sediment removed
- 455 cy non-TSCA soil & 21,834 cy of non-TSCA sediment removed
- 455 cy material disposed at offsite landfill, so far
- Investigating options for abandoned, in-water pipe

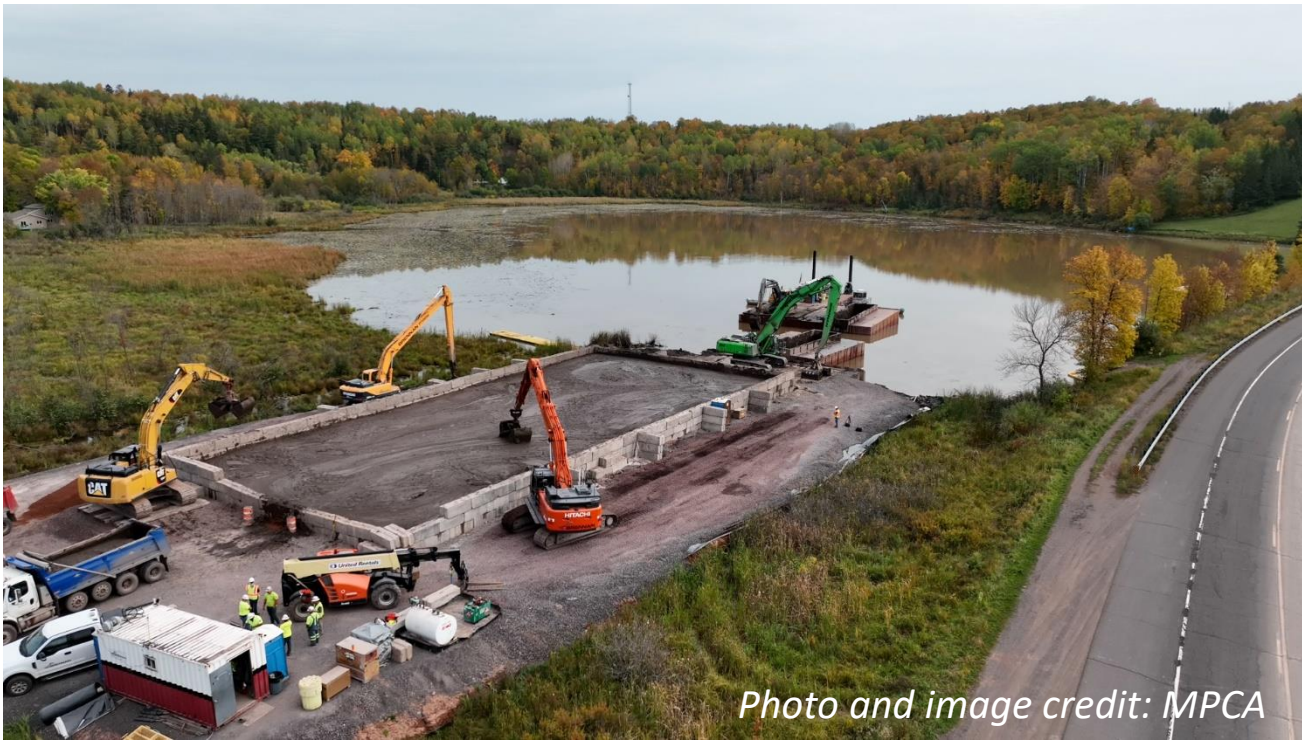
- Phase 1 construction began in June
- Dredged ~60,000 cy clean sediment, with off-site beneficial use
- Constructed hemi-marsh habitat
- Constructed spawning habitat
- Initiated Phase 1 de-mobilization

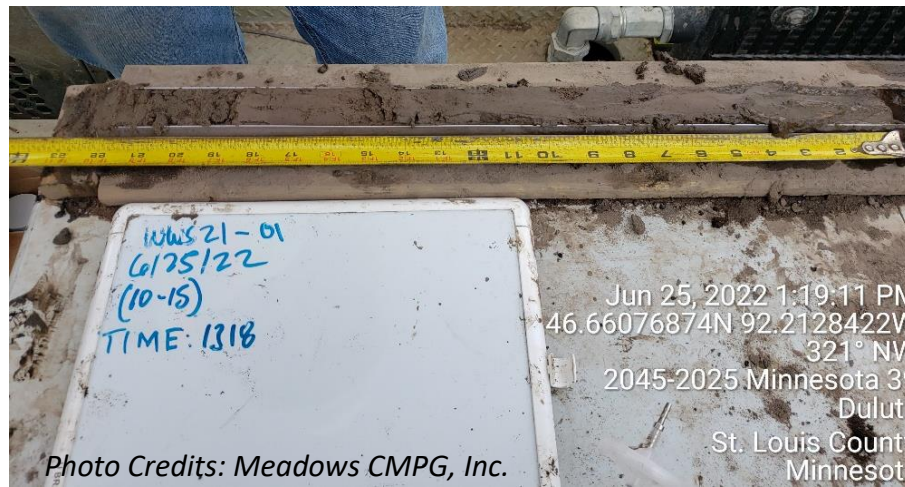
- Data Collection Completed
  - Geotech, sediment, and wood waste – Meadows CMPG, Inc.
  - Bathymetry – Bay West
  - Vegetation – UWS/LSRI
- Hydrodynamic modeling underway
- Developing design alternatives

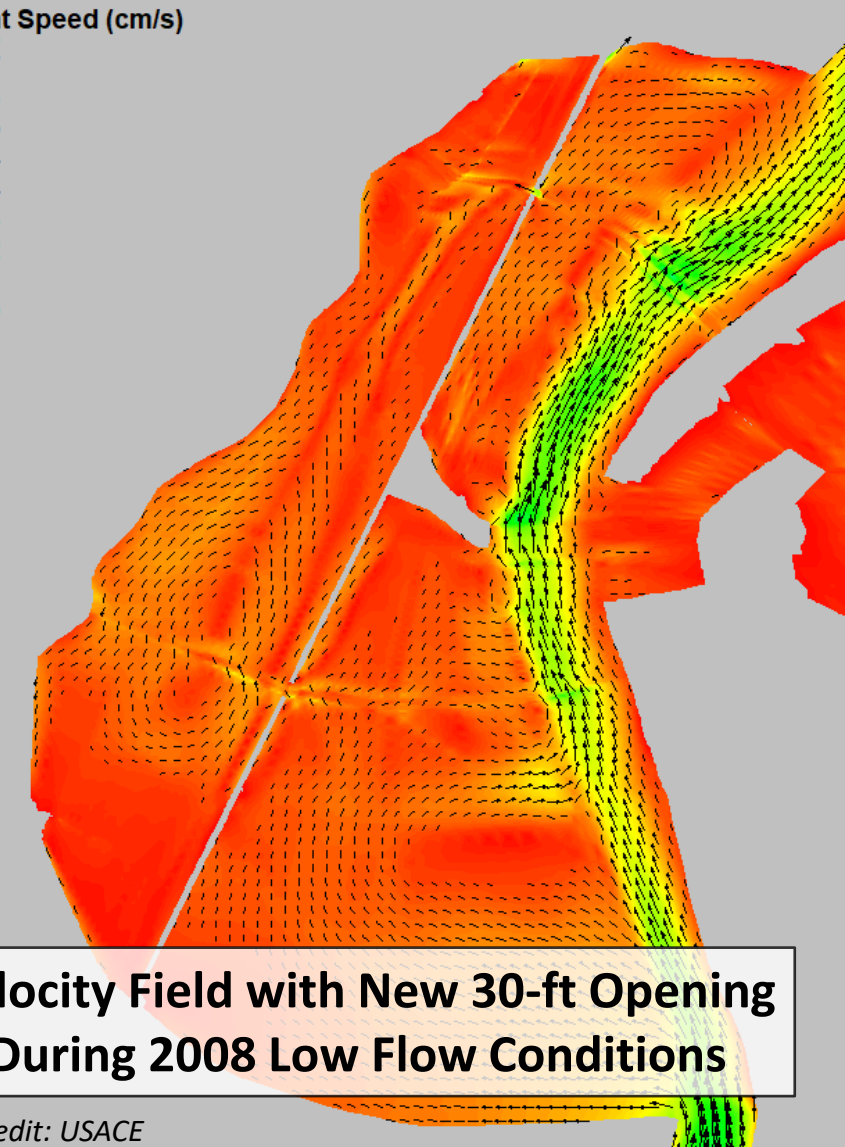
**Velocity Field with New 30-ft Opening  
During 2008 Low Flow Conditions**

Current Speed (cm/s)

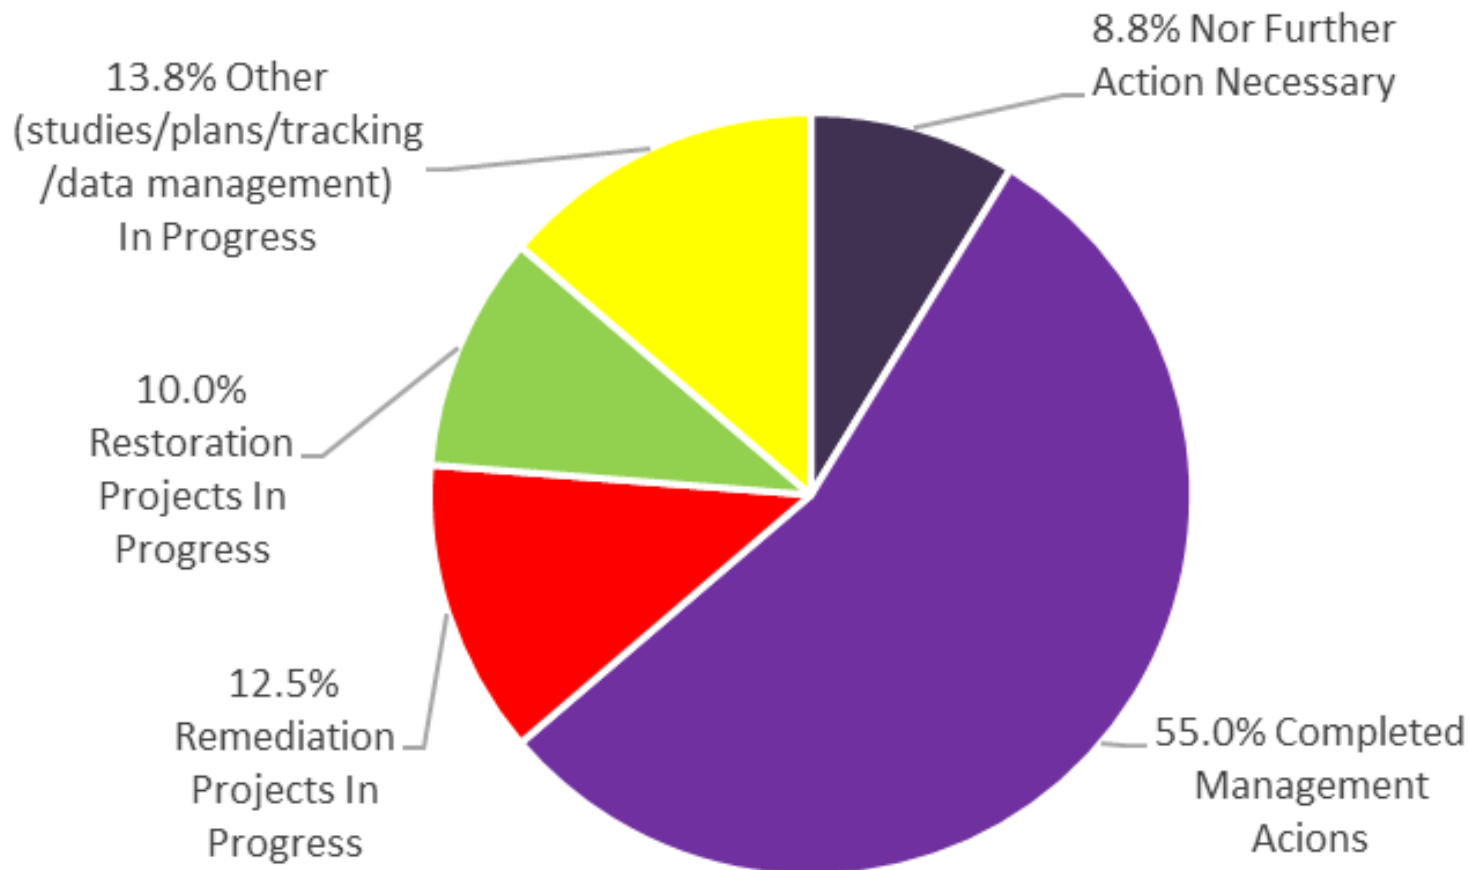
### Management Action Status (9/30/22)

**63.8% Complete**

7	No further action needed
44	Completed
10	Remediation projects in progress
8	Restoration projects in progress
11	Other in progress
0	Not started
<hr/>	
80	Total Management Actions
